Hercules Engine News

This article will cover the procedure necessary to rebuild the head on the 1½ to 2 HP Hercules built engines. Valves, valve guides, rocker arm support mountings and pin and the side rod support hole are all possible areas that may need repair. Although the following remarks are intended for the engines mentioned, many of these same principles can be applied to other sizes and brands of engines.

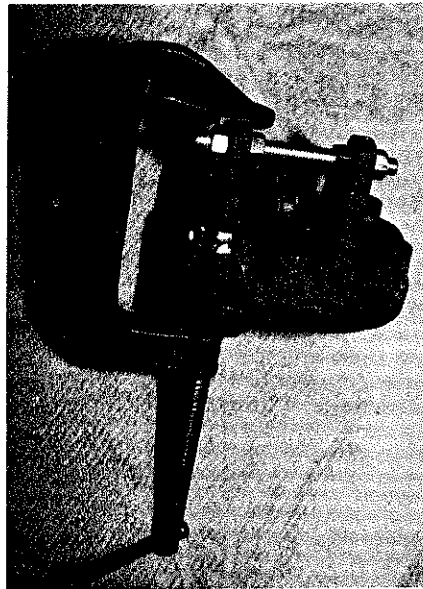
If a rocker arm support is broken off, I use the set up as shown in the picture to line up and hold parts steady for welding.

tap the pin back and forth until it is free. Once the rocker arm pin has been removed, a new one can be made from 3/8 inch rod. If the holes in the support arm are quite loose, I ream them and the rocker arm hole out to 25/64 inch and make a new pin to fit.
