Hercules Engine News

The side rod (exhaust valve rod) on the 1½-2 HP Hercules built engines seems like a simple trouble free part. As the engine runs, the side rod wears in several places. The side rod and other parts involved with it can eventually cause problems. The rod eventually tilts to one side and drops down causing other parts to become out of line.

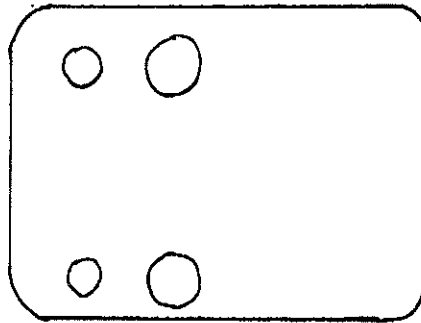
POINTS OF WEAR =

The side rod tends to wear and tilt sideways where it goes through the governor bracket slot. It also wears where it goes through the support on the head which lets the end of the rod drop down. All of this eventually causes the ignition tripping mechanism and the cam follower roller to be out of line. The diagram above illustrates these points of

wear.

Where the side rod rubs against the engine block there will likely be a worn wedge shaped groove. Clean this area and fill it with an epoxy filler. File it down smooth. Make a sheet metal plate similar to the one illustrated using the machined surface of the governor

These wear problems can be corrected by buying a new side rod or making one out of ⅝ by ¼ stock. The old one can also be built up at the wear points and ground and filed back to original shape. Building up the worn points will likely cause the rod to warp and it will need to be straightened.

bracket as a pattern. Place this plate between the governor bracket and the block when reassembling the engine. This provides a new wearing surface. When assembled, the side rod should slide freely back and forth. If it binds, look for high spots to be filed or ground off.
