# Hercules Engine News

## Governor Overhaul

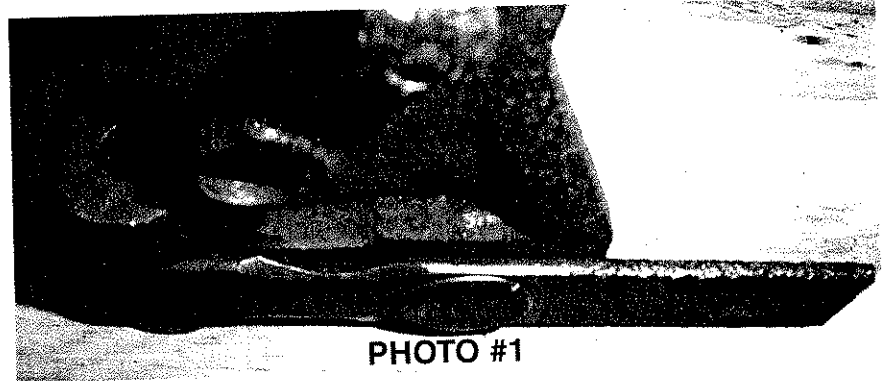
PHOTO #1

Not too long ago, a fellow with a 1-3/4 HP Model S Economy engine stopped by and asked me for some advice on getting it going. Seeing his engine, my attention was immediately drawn to the governor, which was quite worn and needed attention. Photo #1 shows the detent blade, which should be straight. As parts wear, it often becomes necessary to bend the detent blade toward the side rod so it will engage the detent block. When it gets to this stage of wear, it's time for a governor overhaul.

Above, Photo #1:  
*Detent blade should be straight for proper operation.*

The first thing you need to do is straighten the blade, but you also need to find the real cause of the trouble. What you will often find is that the governor spindle pin is badly worn. It should protrude about 3/16-inch at rest, as shown in Photo #2. If you need to make a new pin (a 1/4-inch carriage bolt can be easily modified for this), make it a little longer yet so it can be ground off for the best fit. In addition, the detent fin-

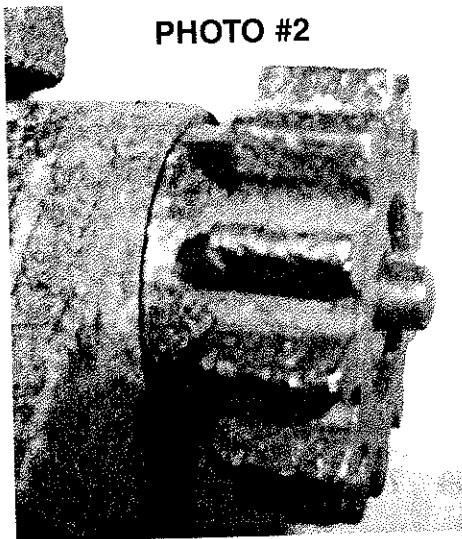
PHOTO #2

Left, Photo #2:  
*Governor spindle pin should protrude 3/16-inch at rest.*

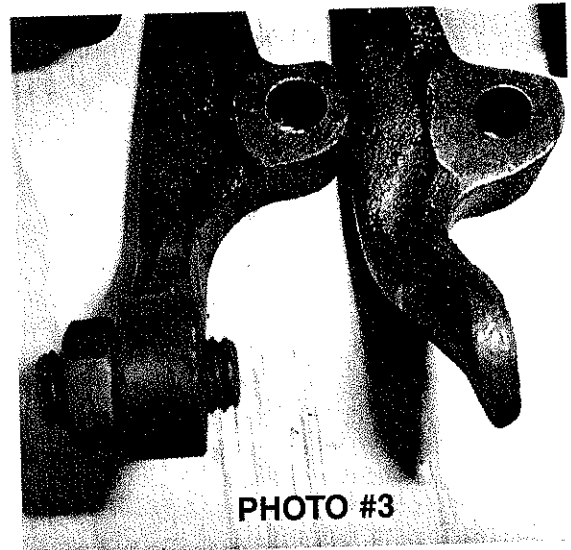
PHOTO #3

ger (Photo #3) often has a depressed hole from wear or the adjusting screw itself will be worn off. Brazing up the hole or replacing the screw may be necessary.

Right, Photo #3:  
*The detent finger on the left is in good shape, while the one on the right has worn considerably.*

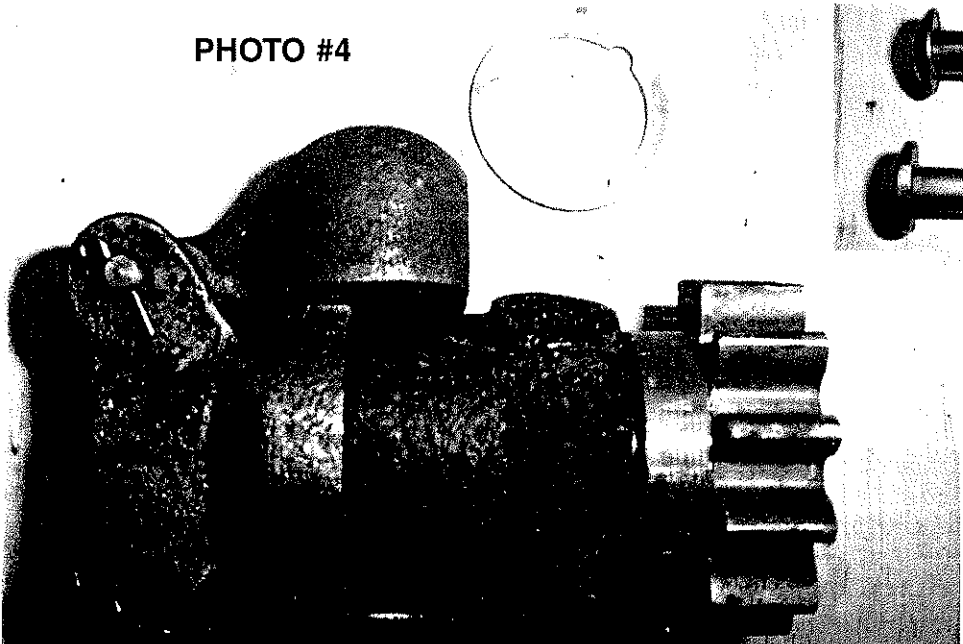
PHOTO #4

On later governors the spindle housing is 1-1/16 inches narrower than the early style and requires a special brass wear washer (Photo #4). The narrower housing is the one with a grease cup rather than just an oil hole. When this washer wears out, the whole governor spindle gradually recedes into the housing, causing more play in the linkages.

Left, Photo #4: A special brass wear washer was used on later model governors.

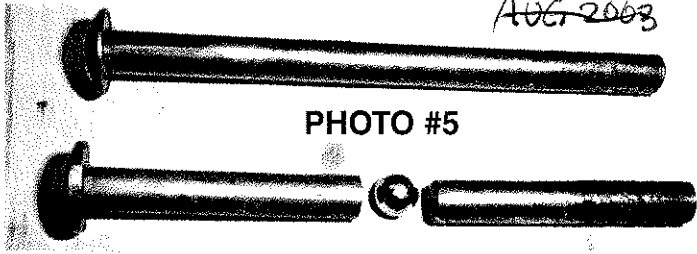
PHOTO #5

Although all parts interchange, there are some important differences. Model E through G engines used one governor design and H and S used another. Photo #5 shows the earlier one-piece spindle pin and the late three-piece pin. The three-piece pin goes with the detent finger with the adjusting screw.

Above, Photo #5: Early production, single piece spindle pin and later production, three-piece pin.

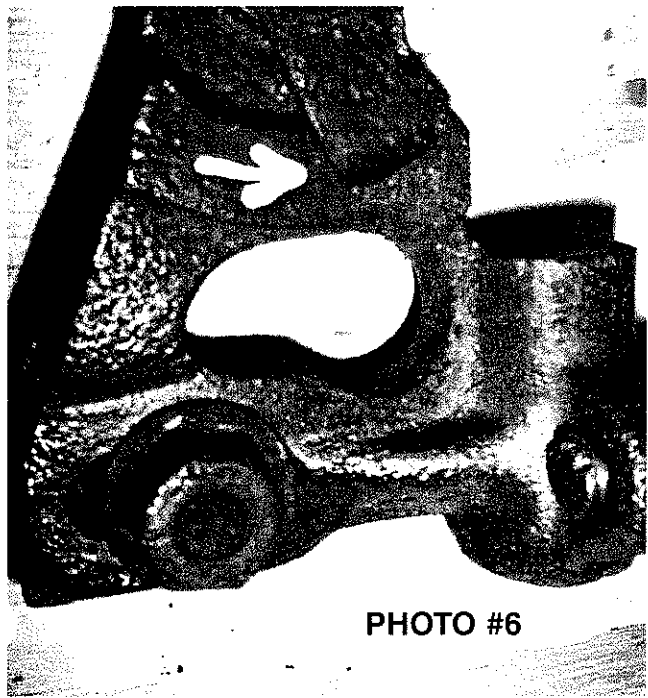
PHOTO #6

Photo #6 shows the earlier detent adjustment handle with a small tapered lip bent out at the bottom. Over time, that lip wears down and makes a corresponding groove in the back of the

Below Left, Photo #6: Early production detent adjustment handle.

detent finger. The later handle had a bump pressed into the bottom and is less prone to wearing out. The pin that the detent mechanism pivots on (Photo #7) also wears, and often needs to be replaced with a new 5/16-inch pin. In extreme cases, it may be necessary to ream the holes out and install a larger diameter pin. When that's the case, grind the bottom end of the pin to a taper so it will be easier to insert.

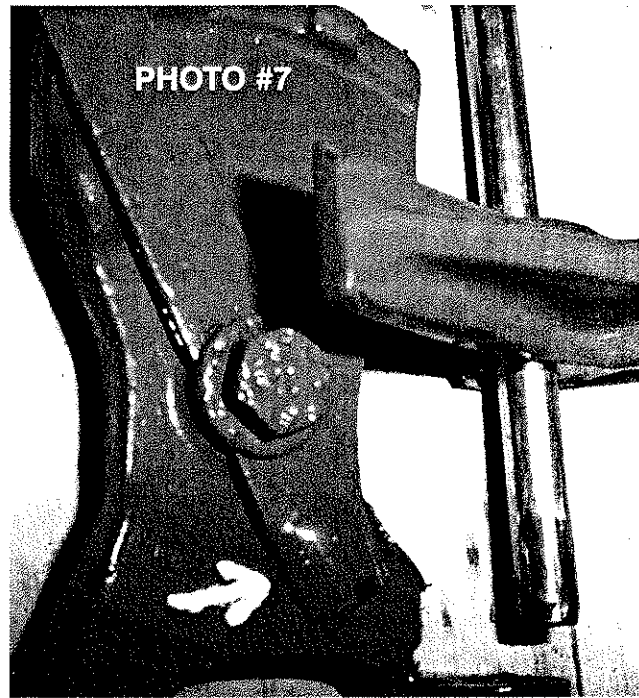
PHOTO #7

Below Right, Photo #7: Detent mechanism.

governor weight pins out of 3/16-inch rod. Peen one end of each pin and the detent pin to make a small head on them. With these repairs complete, the detent blade should just clear the detent block by about 1/16-inch when the speed control lever is forward.
