Hercules Engine News

Including Economy, Arco,
Jaeger & Thermoil

by Glenn Karch
20601 Old State Rd.
Haubstadt, Indiana 47639

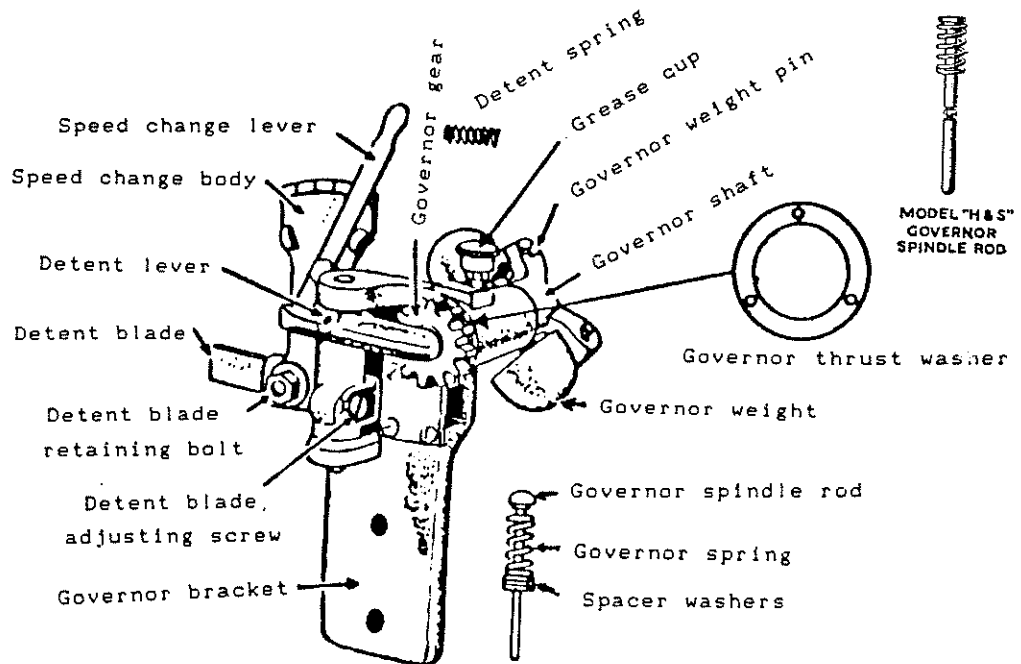
The accompanying illustration, although for the larger engines, shows all the important parts referred to in the article to follow.

Begin with the removal of the entire governor assembly from the engine. On most engines, an offset screwdriver will be a big help to reach in and loosen the slot head bolts used on most engines. Be careful to not let the governor spindle rod fall out (if it is of the "H & S" type). If the end of the rod falls out, you can usually find it, but the little ball will bounce away and hide forever.

Remove the governor weight pins. If they are worn, make new ones from stock of the original diameter ($\frac{1}{16}$ "). Peen one end and drill a cotter pin hole through the other end.

Remove the governor spindle rod, spring and any spacer washers. The head of the spindle rod may have notches worn in it where the governor weight fingers touch it. The other end of the rod may be worn off from turning against the detent

arm finger. A new rod can be made from a $\frac{1}{4}$ " diameter carriage bolt. Make the new rod slightly longer than the old one.

Remove the pin that holds the detent lever and the speed change body on. If it is worn, replace it. The detent arm finger may also have a depression worn in it where the spindle rod turns against it. Braze or weld it back up and grind to original shape. Some detent arm fingers have a wear button that may need to be replaced. The "H & S" governor detent arm may need a new adjustment screw. Sometimes a notch is worn in the opposite end of the detent arm where it touches the speed change lever. This may also need to be filled in. There is a small spring that causes the detent to unlatch for the power stroke. It only needs to be strong enough to push the detent lever out. The speed change lever bottom protrusion may be worn off and require building back up.

Remove the governor gear from the shaft by turning counterclockwise. It has righthand $\frac{1}{4}$ " NF threads. Be sure to loosen the governor gear retaining screw if it has one in the gear collar. Be careful not to break an ear off the governor shaft. Clamp the ear end in a vise and use a pipe wrench on the gear. If it

doesn't come off easily, use a propane torch and heat the gear. That usually does it. There should be a brass thrust washer between the gear and the housing. It is often gone or worn too thin. Make a new washer just thick enough so it doesn't bind when the gear is retightened. Unless the governor body and shaft have been broken, they are seldom too worn to use.

Finally, the detent blade should be straight and the end ground to an 80 degree angle so it will catch on the block. The catch block is reversible if badly worn. It can be refaced to a new 85 degree angle by using a narrow abrasive disk on a Dremel type tool.

Reassemble the governor using a few drops of oil at all moving points. Loosen the detent blade retaining screw and turn the detent blade adjusting screw until the blade just goes in behind the catch block when the side rod is all the way out (on the high point of the cam).
